Your Inspection Report

2605 Kingston Road
Toronto, ON M1M 1M1

INSPECTION DATE:
Tuesday, January 12, 2021

RE: Report No. 1587
2605 Kingston Road
Toronto, ON
M1M 1M1

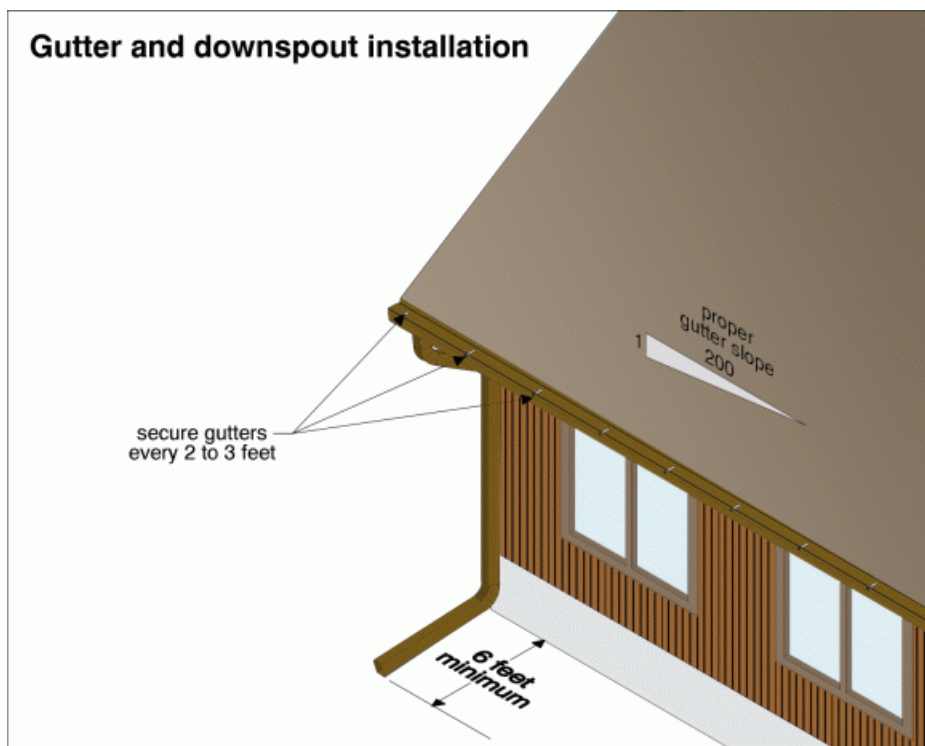
1. Condition: • [Discharge too close to building](#)

Implication(s): Chance of water damage to structure, finishes and contents

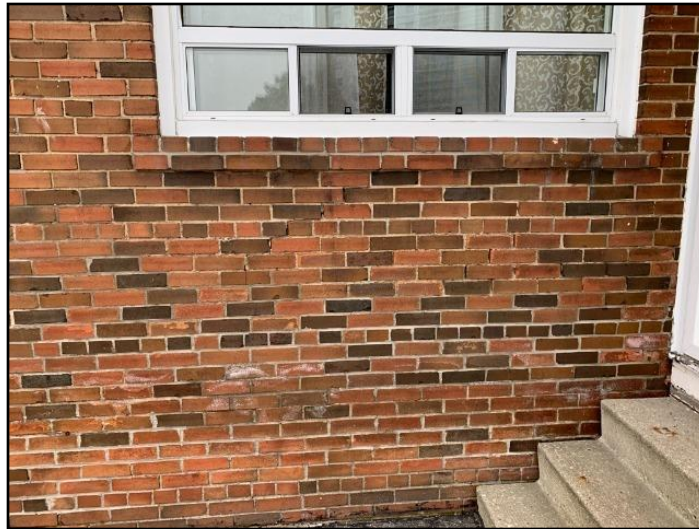
7. Cracked

3. Condition: • [Cracked](#)

Minor settlement cracks noted

Implication(s): Chance of water entering building | Weakened structure | Chance of movement

Location: Front

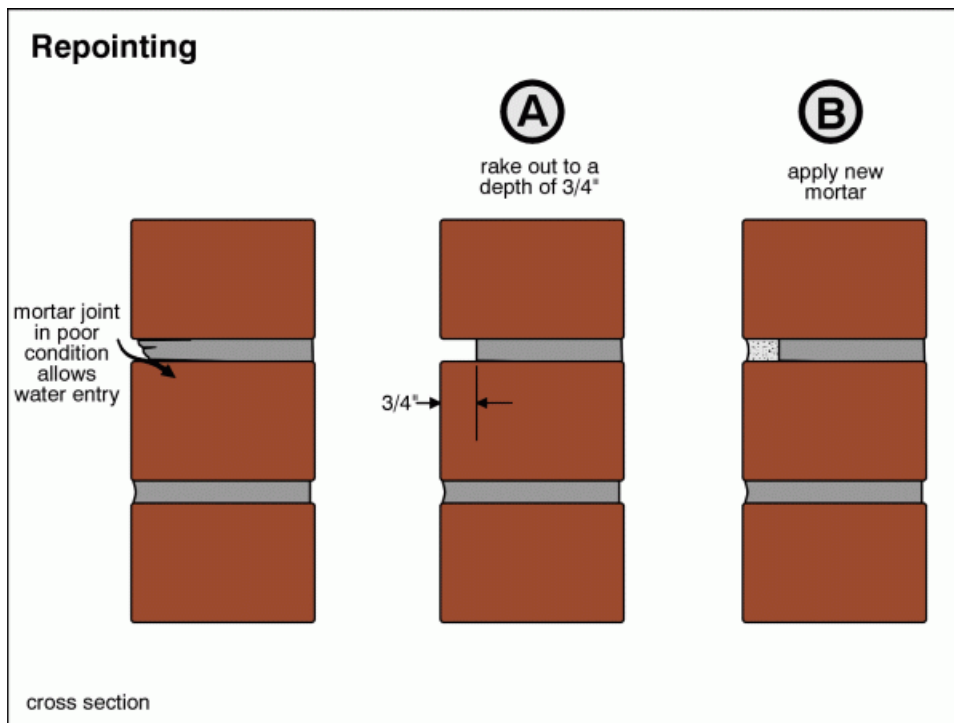
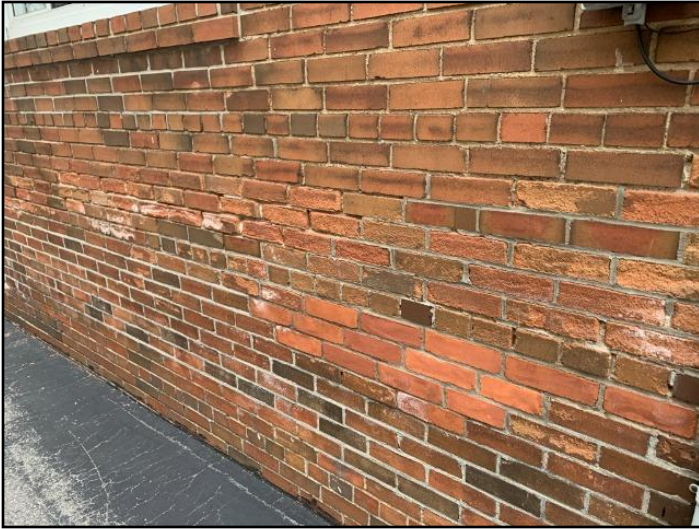
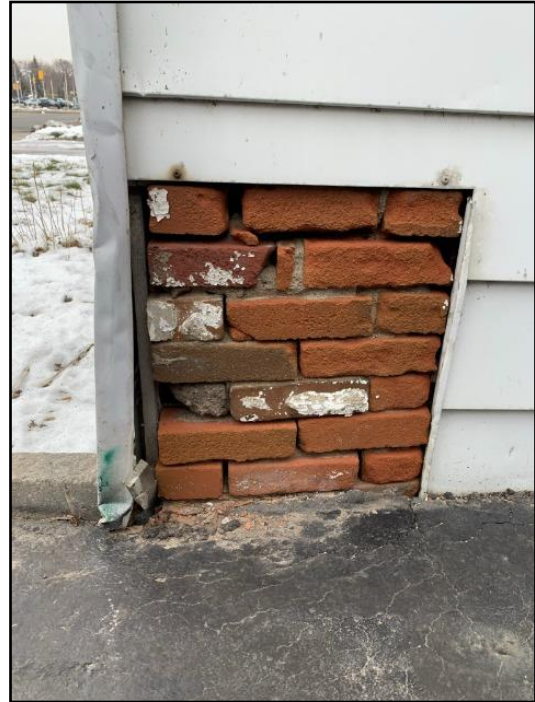
8. Mortar deterioration

4. Condition: • [Mortar deterioration](#)

Implication(s): Chance of water entering building | Weakened structure | Chance of structural movement

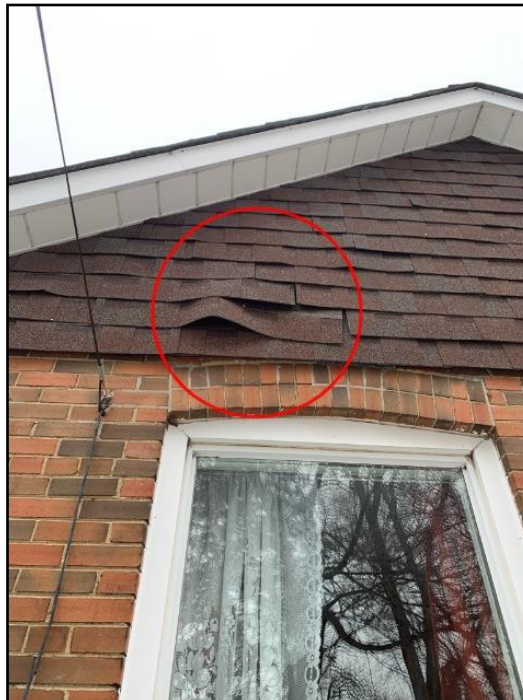
10. Loose, missing or torn tabs

5. Condition: • Loose, missing or torn tabs

Location: Rear

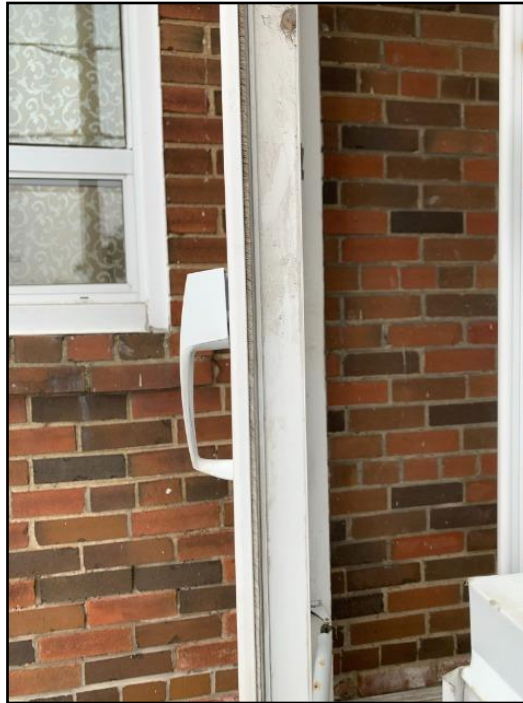
11. Missing or damaged

7. Condition: • Missing or damaged

Implication(s): Increased heating and cooling costs | Poor security

Location: Front

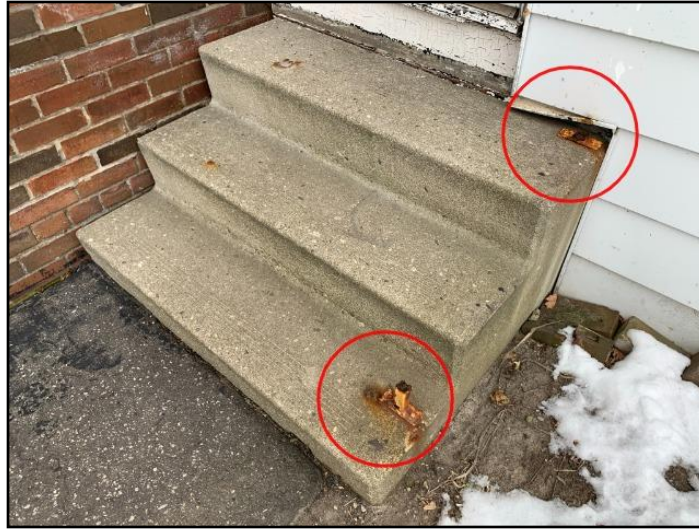
12. Missing

9. Condition: • [Missing](#)

Implication(s): Fall hazard

Location: Front

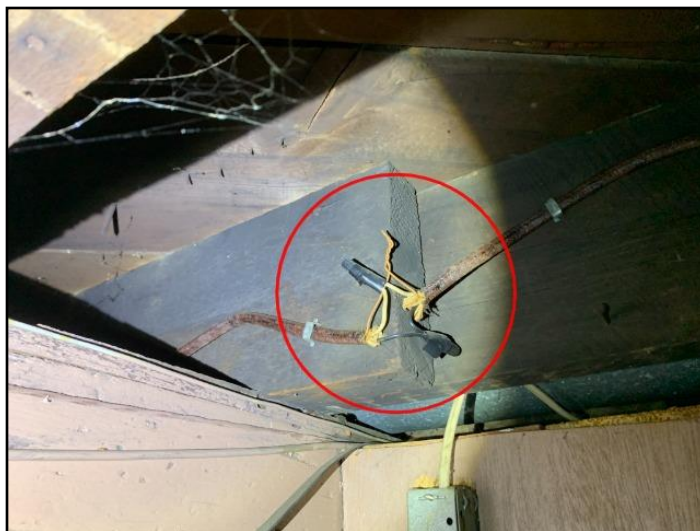
25. Damage

10. Condition: • [Damage](#)

Implication(s): Electric shock | Fire hazard

Location: Basement

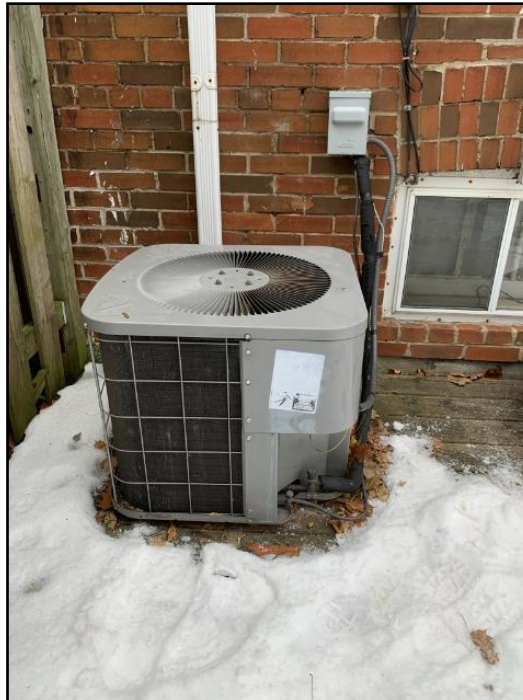
30. ICP

Compressor approximate age: • 18 years

Typical life expectancy: • 12 to 15 years

Failure probability: • [High](#)

11. Condition: • Past life expectancy

Implication(s): Equipment failure | Reduced comfort

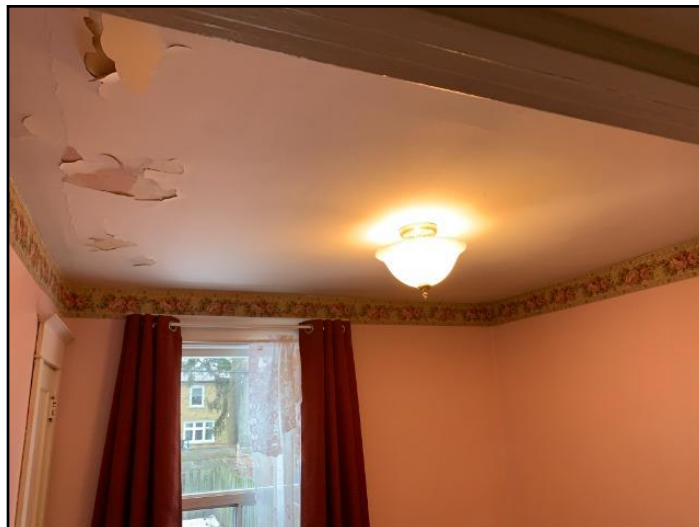
37.

14. Condition: • Peeling Paint

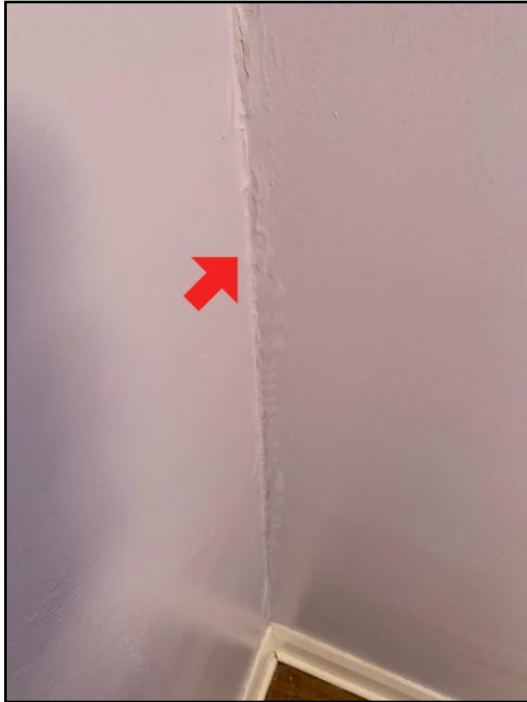
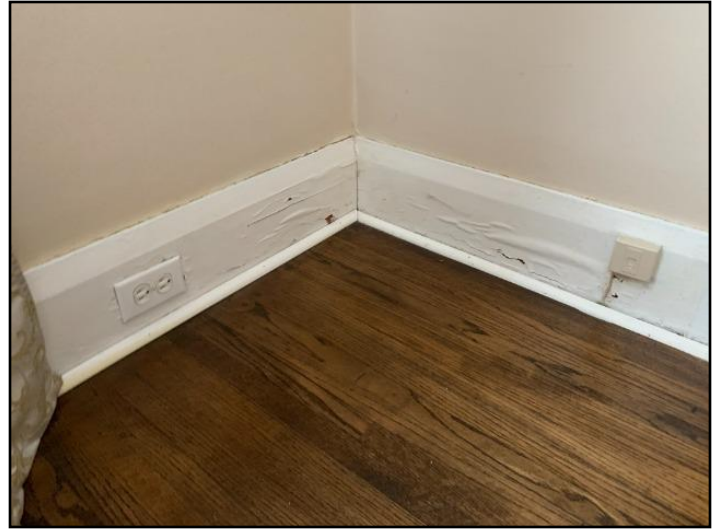
38. Water damage

15. Condition: • [Water damage](#)

No evidence of a current leak

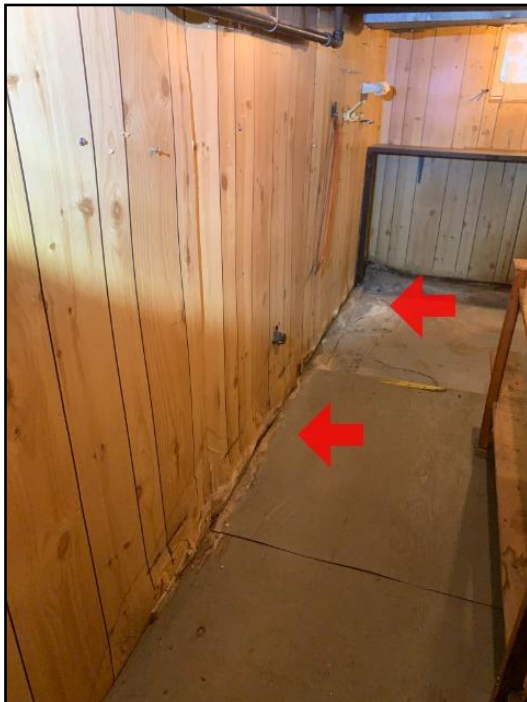
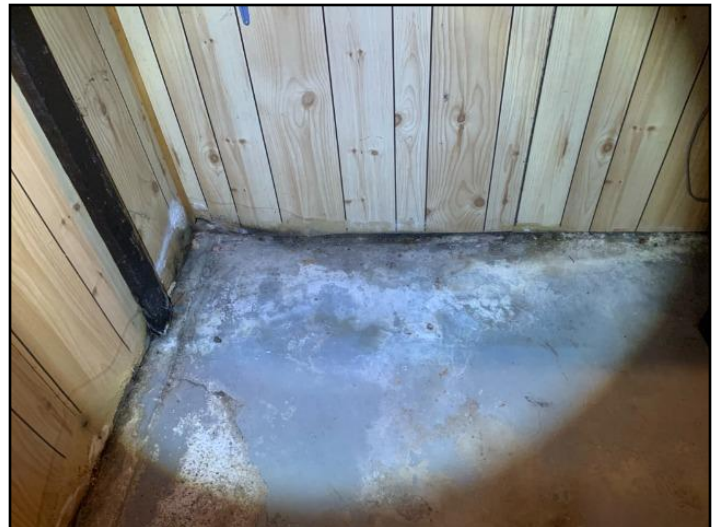
40. Leakage - Read these articles before...

Evidence of basement leakage: • Present • Stains • Dampness

16. Condition: • [Leakage - Read these articles before undertaking any action](#)

Implication(s): Chance of water damage to structure, finishes and contents

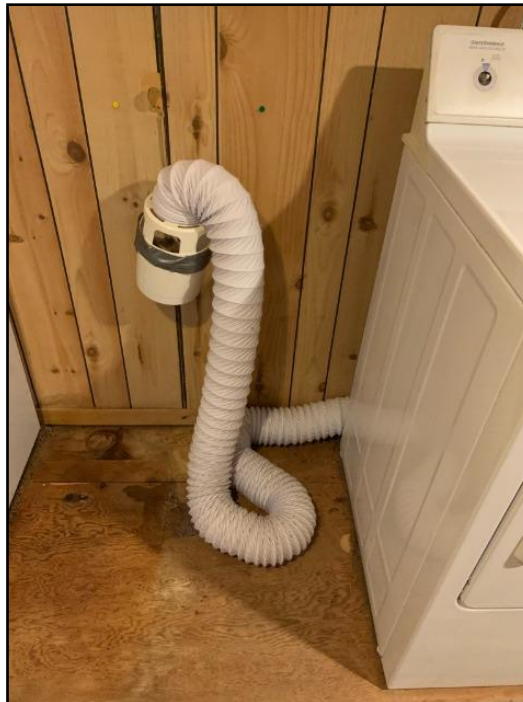
- Appliances are tested for basic operation only.
- The Problem with dryer vent diverters is moisture condensation in homes. All of the wetness in the clothes that were just washed is being expelled from the dryer vent. In dry climates, this added air moisture might be an advantage. In areas with moderate to high humidity, the moisture from a dryer could promote condensation and the growth of mold.

Another problem is the potential for lint build-up in the home; a potential fire hazard. This can occur if the water level in the reservoir is forgotten and allowed to evaporate. Lint can then bypass the diverter and vent into the home

49. The Problem with dryer vent diverters is...
